RAILWAY INVESTIGATION REPORT
R03D0042

MAIN-TRACK TRAIN DERAILMENT

ST. LAWRENCE & ATLANTIC RAILROAD

MILE 43.93, SHERBROOKE SUBDIVISION

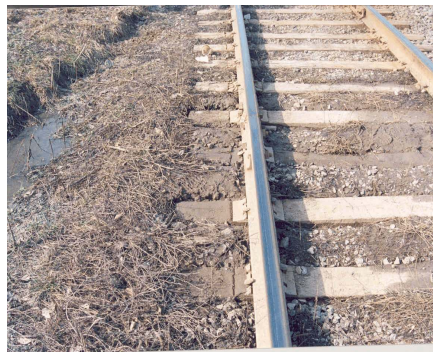
The track structure consists mainly of 100-pound jointed rail, in 39-foot lengths, manufactured and laid in 1955. The track was laid on hardwood ties with double-shouldered tie plates secured by four spikes per tie. In the derailment area, the ballast was contaminated and waterlogged as the roadbed was not adequately drained (see Figure 1). Evidence of track pumping,¹ particularly at the approach to the Dépôt Street crossing, was observed.

Figure 1. Contaminated ballast and track pumping

The ballast contamination and state of saturation of the roadbed in the approaches to the Dépôt Street crossing indicate track wear, which leads to additional wheel impacts and abnormal deformation under the cars. Track wear was further confirmed by pumping at the joint of the broken rail, the worn condition of the rail joint spikes and the ovalization of the rail joint bolt holes. The event recorder indicated that the speed of the train was in excess of the speed limit in effect near the Collège Street crossing. Consequently, the forces generated by the axles of this train would have been greater than the forces generated by other trains, explaining why the rail failed under this train.

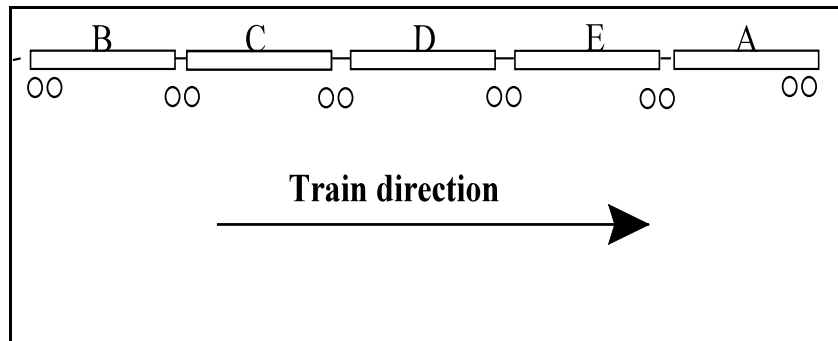
The head locomotive stopped at Mile 42.32. The first two derailed cars (the 84th and 85th) were platforms C and B of container car TTAX 553649 (see Figure 2). Forty-foot containers were carried on each platform, and the container on platform C weighed about 12 tons. Platforms C and B remained upright and coupled to the front portion of the train. They came to rest approximately 200 m east of the Collège Street crossing and the other derailed cars came to rest to the west of the crossing. The 90th car, MEC 31856, a boxcar, came to rest 2 m from buildings in a shopping centre located to the south of the railway right-of-way. The tank car loaded with caustic soda remained upright and did not leak. Its content was transshipped into tank trucks. A total of 150 m of track was destroyed.

Figure 2. Configuration of car TTAX 553649

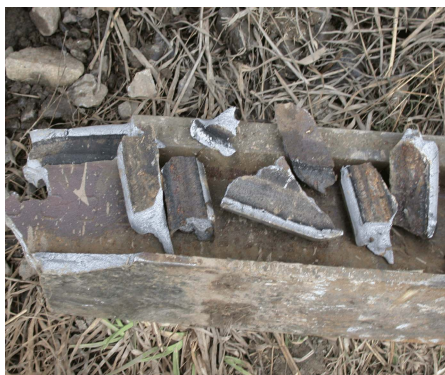
Several small fragments of the running surface of the rail and two 75 cm-long pieces of rail were recovered on the east side of the south rail joint. Examination of the recovered broken rail pieces revealed a horizontal fracture of the rail between the head and the web (head-web separation), a vertical fracture in the head, along with transverse cracks (see Figures 3 and 4). The location of the fractures was between the rail joint splice bars, and the fracture surfaces were significantly oxidized. Also, the rail joint bolt holes were ovalized and the spikes that held the rail joint in place were worn. The tie under the east rail end of the joint showed deterioration.

Figure 3. Rail head fragments

The heavy oxidation on the surfaces of the rail fractures indicate that the track had pre-existing cracks for some time and gave way under the train. Because of the relatively light weight of the platforms (platform C—12 tons), it is most likely that the rail failed under the weight of heavier cars that passed before the platforms.

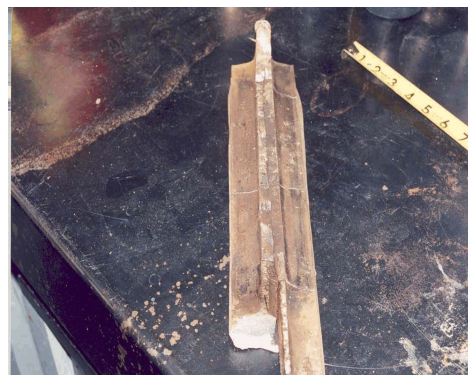
Figure 4. Horizontal fracture of the rail web

The rail fractures occurred at the rail end, between the rail joint splice bars. Therefore, pre-existing horizontal and vertical rail cracks were not visible and thus would be undetectable during a visual inspection. In addition, the most recent testing of the rails was done in June 2002. Thus, the cracks would have had sufficient time to develop even with the relatively light traffic.

1. The rail fractures were discoloured and oxidized, indicating that the cracks had been present for some time.
